TS-PIC-92075 August 1992

SEPA Site Analysis U.S. Smelter and Lead Refinery, Inc. East Chicago, Indiana

Site Analysis U.S. Smelter and Lead Refinery, Inc. East Chicago, Indiana

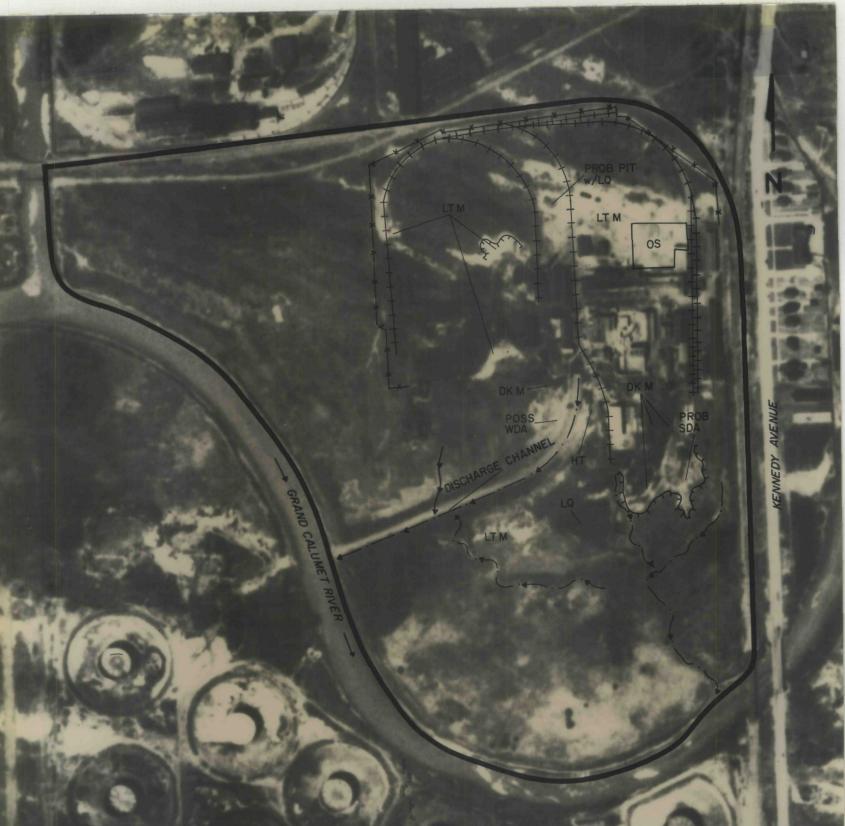
FIGURE 3 U.S. SMELTER & LEAD REFINERY

Due to the poor quality of the October 31, 1938 film, the 1939 film will be the earliest photograph used in showing the U.S. Smelter and Lead Refinery in operation. Because of the poor film resolution, many features could not be positively identified. However, some of the features that were noted during this year are areas of probable furnace dust, seen as the light-toned (LT) material (M), and the disposal and/or storage of probable furnace slag material which is seen as dark-toned (DK) material. The light-toned probable dust areas are visible generally north and west of the facility, while the dark-toned probable slag material areas are generally south of the facility. Both of the aforementioned areas were also visible on the 1938 film. Horizontal tanks (HT), a probable slag disposal area (SDA), open storage (OS) areas, a probable pit with liquid (LQ), and areas of possible waste disposal (WDA) are also visible.

According to collateral data, much of the dust was stored and/or disposed in the northern portion of the site, while the slag was disposed primarily in the slag disposal area along the south edge of the facility. This slag was used as fill material along the wetland areas.

A drainage analysis was performed for this year. Any significant changes observed in subsequent years will be annotated and discussed. The surface drainage appears to flow southward to merge with the Grand Calumet River, which empties into Lake Michigan. The discharge channel noted south of the facility will no longer be annotated, due to its consistent presence throughout the analysis.

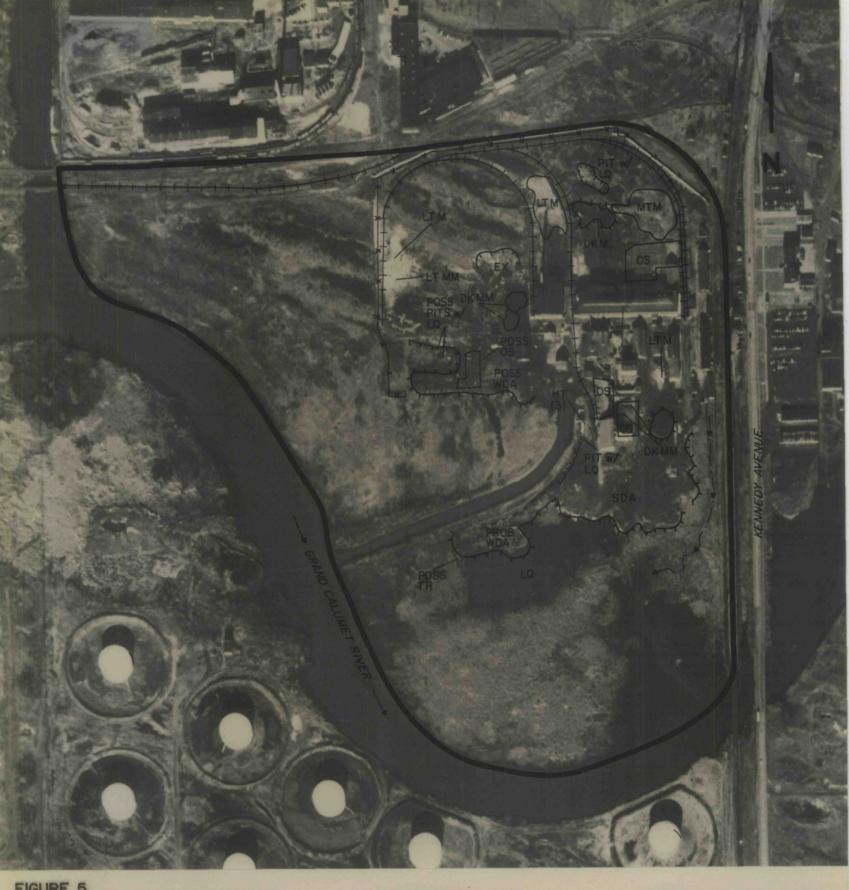
FIGURE 5
U.S. SMELTER & LEAD REFINERY

The area of light-toned mounded material along the western fenced area is still present. Excavation (EX) activity is noted in an area where light-toned material was previously seen. One large pit containing liquid is seen in the area in which the two possible pits were noted north of one large mound of dark-toned material. The northeastern area of light-toned material that was seen in 1949 appears to contain a combination of both light- and dark-toned material and is annotated as medium-toned (MT) material. The northeastern open storage area is empty. One large area of light-toned material is discernible east of an open storage area. Three large areas of dark-toned mounded material are noted north of the slag disposal area. Two of these mounds appear to be in an open storage area. Another probable waste disposal area is visible along the southeast edge of the discharge channel. A possible trench (TR) is noted along the south edge of the discharge channel. A small possible open storage area is discernible south and east of an area that appears to be a shallow depression that contains two possible pits with liquid. The possible waste disposal area containing several piles of debris (not annotated) is still visible in the southwestern portion of the facility. A probable area of liquid within the wetlands is noted south of the possible waste disposal area. A possible access road (not annotated) leads from the western fence line to near the Grand Calumet River.

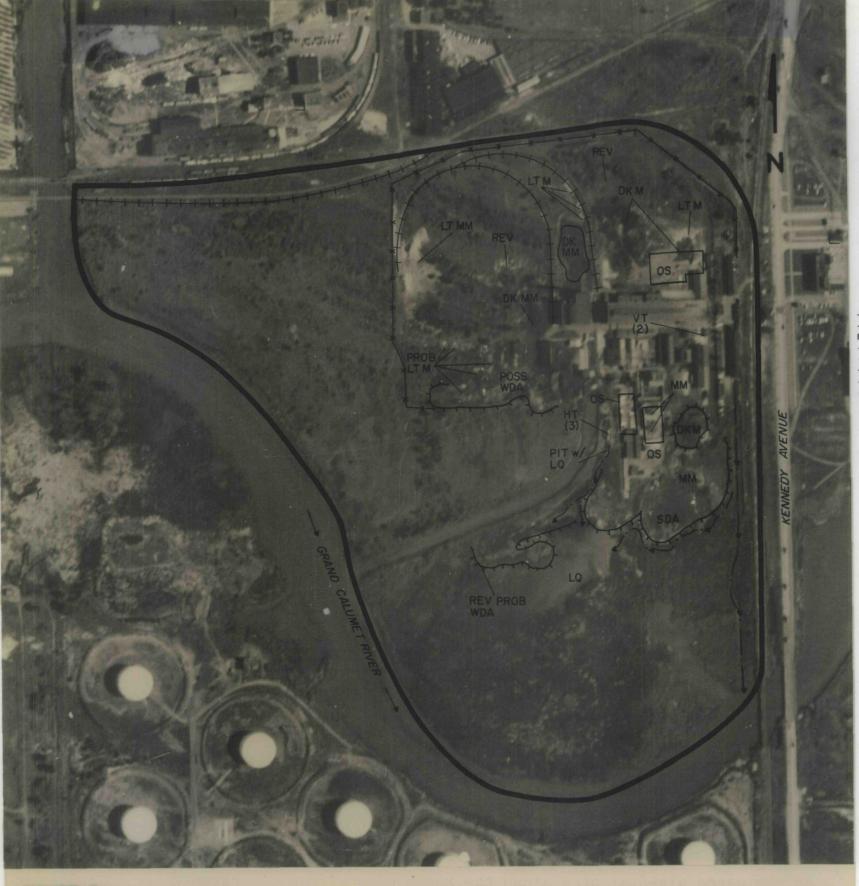
FIGURE 6
U.S. SMELTER & LEAD REFINERY

Due to the poor quality of the film, many of the features noted could not be positively identified. The pit and excavation areas that were noted in the north central portion of the site in 1951 appear to have been filled and are in a state of revegetation (REV). The area of light-toned mounded material seen along the western fenced area is still present, but no activity is noted in this area at this time. The large mound of dark-toned material seen in 1951 is still present, and a second mound of dark-toned material occupies a portion of the eastern open storage area. An area of light-toned material is visible adjacent to the mound of dark-toned material. Little activity is noted at the northeastern open storage area. Two large areas of mounded material are discernible east of the discharge channel. A large area of dark-toned mounded material is noted north of the slag disposal area. Several other smaller mounds of material (not annotated) are present to the north of the slag disposal area. The probable waste disposal area seen along the southeast edge of the discharge channel is still present. A possible drainage channel is emanating from the liquid-filled pit south of the three horizontal tanks. The possible waste disposal area containing several piles of debris (not annotated) and mediumtoned material (not annotated) is still visible. The probable area of liquid noted south of the possible waste disposal area in 1951 is no longer discernible.

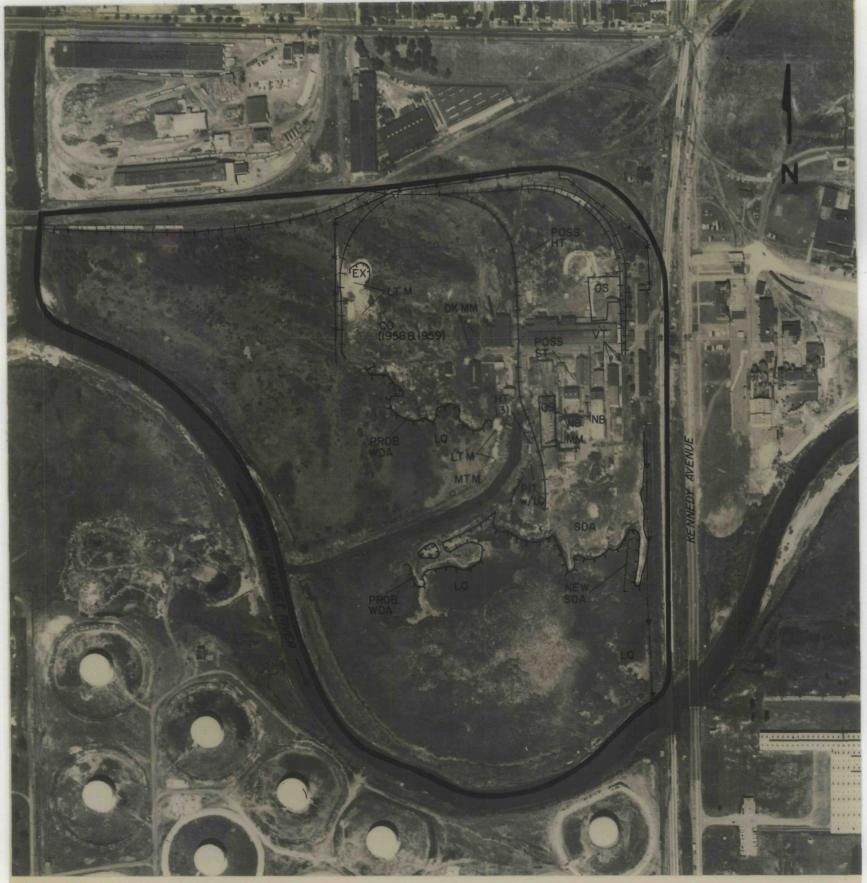
FIGURE 7 U.S. SMELTER & LEAD REFINERY

Most of the north central portion of the site appears to be revegetating, and no significant features or activities are noted. Excavation activity is apparent in an area of light-toned material along the western fenced area. Although the excavation area appears to be in the same general vicinity as that seen in 1949, the activity covers a larger area. The two areas of dark-toned mounded material are visible southwest of a possible horizontal tank and west of the most northwestern building. In 1958 a probable drainage ditch (not annotated) was seen between the two centrally located railroad tracks, in the same location where an area of dark-toned material was seen in 1954. The probable drainage ditch appeared to flow north away from the building.

A large horseshoe-shaped area is visible north of the eastern open storage area. This area is first seen in 1958 and probably acts as a tractor trailer turnaround area. Several possible crates (not annotated) are noted within the adjacent open storage area. In 1958 two other areas of light-toned material were visible in and near the western portion of the same open storage area. Only one area of light-toned material is visible in 1959. Four vertical tanks are discernible in the eastern portion of the facility; three were visible in 1958.

Possible stains are noted northeast of the centrally located open storage area. Two new buildings (NB) are visible at the center of the facility adjacent to the open storage area, which contained mounded material in 1954. Both of the buildings were first seen in 1958. Several (approximately 25-30) mounds of variably textured and toned material were noted in and around the slag disposal area in 1958. Thirteen mounds of material (not annotated) are present during this year of analysis. The extent of the waste disposal area along the south edge of the discharge

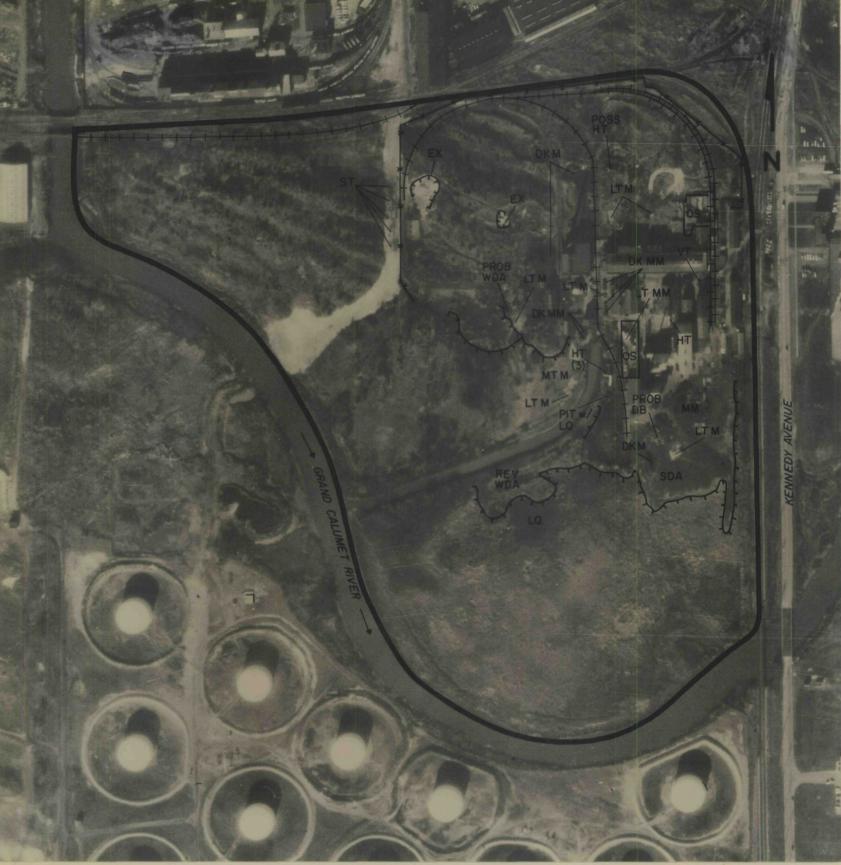
FIGURE 8 U.S. SMELTER & LEAD REFINERY

An area exhibiting several stains is noted adjacent to the excavation area which is located in the western portion of the facility. This area appears to have been excavated in order to lay a possible pipeline. No change is noted at this excavation area, but some activity is noted in the smaller excavation area to the east. The smaller excavation area is larger than it was in 1959. With the exception of the smaller excavation area, the north central portion of the site appears to be inactive. Two areas of dark-toned material are visible west and southwest of the possible horizontal tank. Several possible crates (not annotated) are noted within the open storage area in the northeast corner of the site. The two areas of light-toned material seen in 1959 are still visible in and near the western portion of the eastern open storage area. Only one of the four vertical tanks seen in 1959 is discernible northeast of the open storage area at the center of the facility. Several mounds of variably textured and toned material are visible in and around the slag disposal area. The waste disposal area along the south edge of the discharge channel has apparently been left to revegetate. The area of light- and medium-toned material that was partially aligned along the north edge of the discharge channel is still visible. Several small areas of light-toned material are seen within the probable waste disposal area west of the facility.

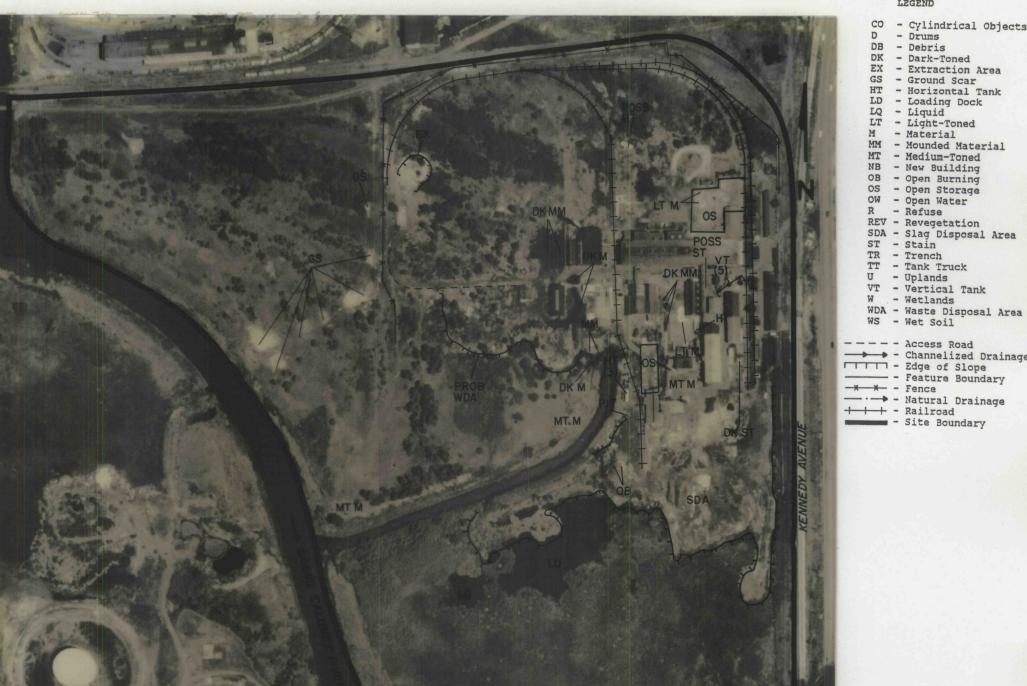
U.S. SMELTER & LEAD REFINERY

Revegetation is still apparent in most of the north central portion of the site. Little if any excavating activity is visible since the previous year of analysis in the area of light-toned material along the western fenced area. The two areas of dark-toned mounded material that were visible west and south of the most northwestern building are still present. A possible loading dock (not annotated) is seen at the northwest corner of the eastern open storage area. Several possible crates (not annotated) and smaller areas of light-toned material are noted within the open storage area. Five vertical tanks are visible south of the open storage area. Possible stains are noted west of the vertical tanks. Still visible in and around the facility and the slag disposal area are several mounds of variably toned and textured material. Two areas of open burning (OB) are evident on the south edge of the discharge channel.

The area of medium-toned material that is partially aligned along the north edge of the discharge channel has increased in size. Another possible area of medium-toned material is discernible in the western portion of the site, near the end of the discharge channel.

Seven ground scars (GS) are visible in the western portion of the site. These ground scars may have been left from the pipeline ground scar seen in 1961.

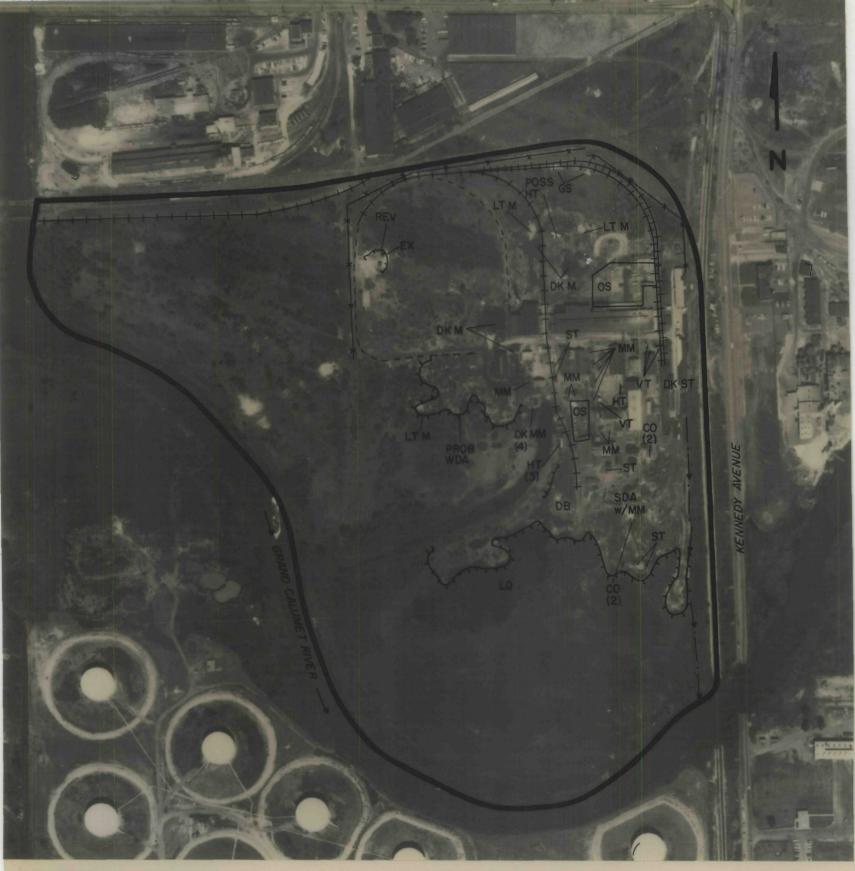
FIGURE 10 U.S. SMELTER & LEAD REFINERY

Two light-toned areas of material are visible adjacent to the possible horizontal tank. Two ground scarred areas are noted in the northern portion of the site along the railroad. Two areas of dark-toned material are discernible west of the eastern open storage area. The area of light-toned mounded material along the western fenced area is still present, but no activity is noted in this area at this time. Partial revegetation is apparent in the northern portion of the excavation. Two other areas of dark-toned material which are adjacent to the most northwestern building are still present.

Numerous mounds of variably toned and textured material are evident throughout the facility, especially north of the slag disposal area. Approximately four cylindrical objects and two stained areas are seen within the slag disposal area. Debris is also noted in the western portion of the slag disposal area. Several vehicles (not annotated) are seen within the open storage area east of the discharge channel. Four mounds of dark-toned material are evident at the north end of the discharge channel. The probable waste disposal area appears to contain several piles of debris in addition to the mounded material previously visible. An area of light-toned material is visible in the southwestern portion of the probable waste disposal area.

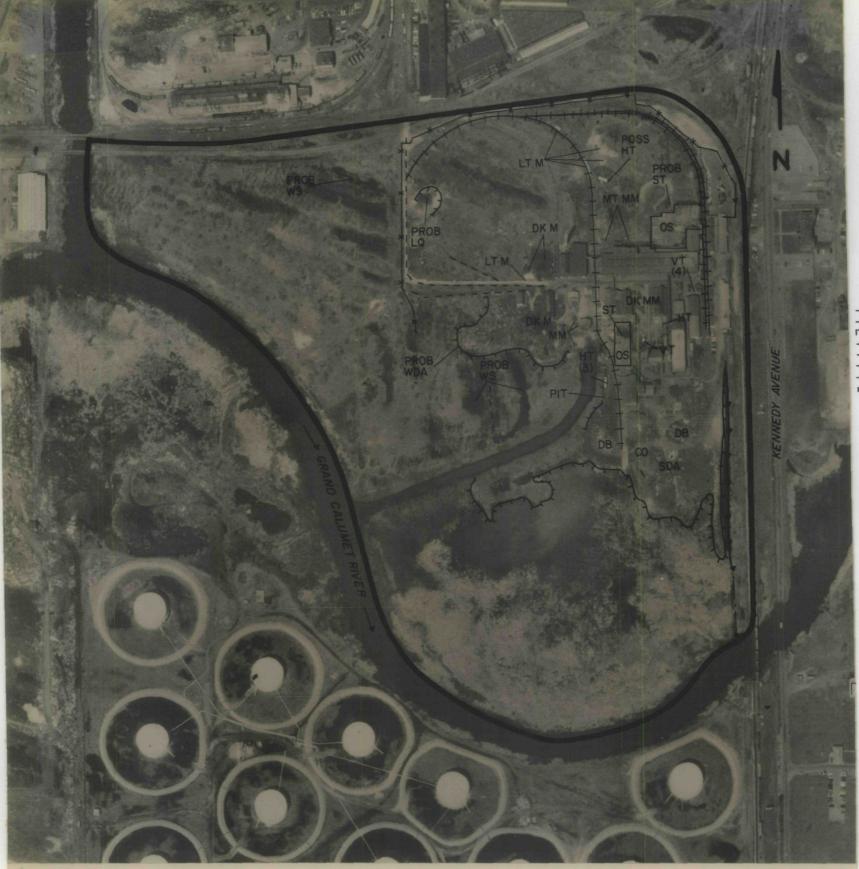
FIGURE II U.S. SMELTER & LEAD REFINERY

Two areas of medium-toned mounded material and four areas of light-toned material are visible south and northwest of the horseshoe-shaped loading dock area in the north central portion of the site. An area of probable staining (not annotated) is noted east of the loading dock. Three small mounds of material are seen south of the possible horizontal tank. The large excavation area along the western fence line appears to contain probable liquid. A small network of access roads runs parallel to the fence as well as running east/west along the center of the site. A few possible vehicles (not annotated) are visible near the southwest corner of the access roads, but no other activity is noted in this area. The two areas of dark-toned material which were adjacent to the most northwestern building are still present. Again numerous mounds of variably toned and textured material are evident throughout the facility, especially north of the slag disposal area. One cylindrical object is seen within the slag disposal area. This object may be one of the five vertical tanks seen in the eastern portion of the facility. Debris is still visible in the western portion of the slag disposal area. A large stain is seen within the open storage area east of the discharge channel. A building (not annotated) appears to have been removed from near this open storage area. Three mounds of medium-toned material are seen at the north end of the discharge channel. The probable waste disposal area seen northwest of the discharge channel appears to contain several small areas of debris and mounded material (not annotated) which are still visible from the previous year of analysis. Two large elongated areas of probable wet soil (WS) are visible in the south central portion of the site. One other area of probable wet soil is noted northwest of the facility.

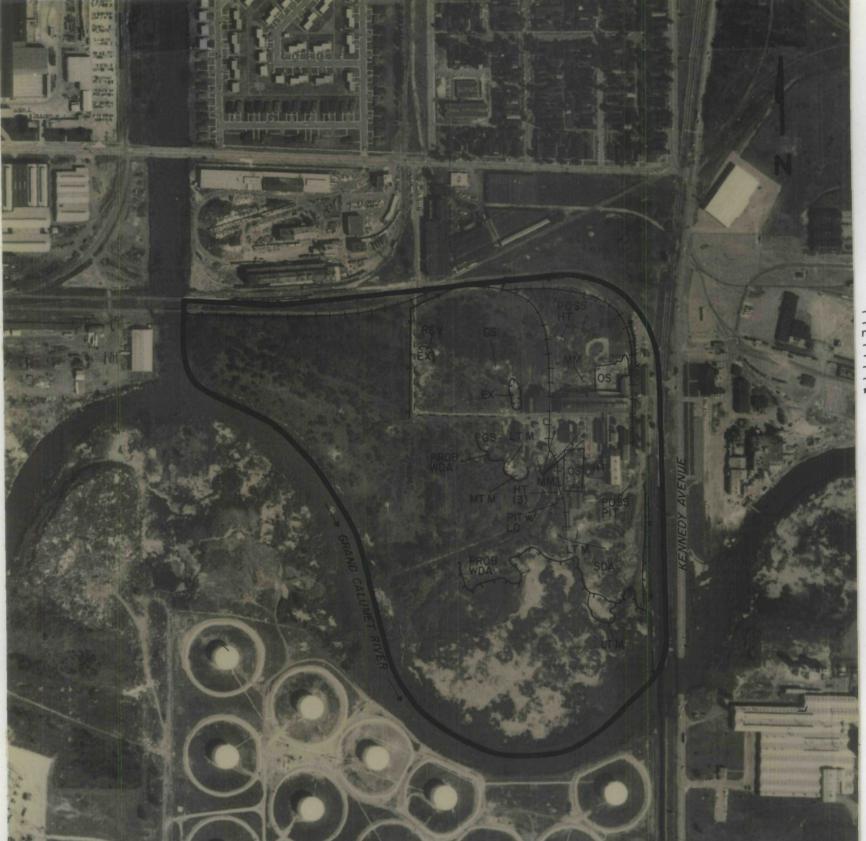
FIGURE 12 U.S. SMELTER & LEAD REFINERY

The two light-toned areas of material that were visible adjacent to the possible horizontal tank are no longer present. One of the two ground scarred areas noted in the northern portion of the site along the railroad is still visible. No areas of dark-toned material are discernible in the north central area. The area of light-toned mounded material along the western fenced area is still present, but no activity is noted in this area. Partial revegetation has taken place throughout the excavation. Another area of excavation is seen at the same location where an area of dark-toned material was previously noted, adjacent to the most northwestern building. Only a few objects and items (not annotated) are discernible at the eastern open storage area.

Numerous mounds of variably toned and textured mounded material are again evident throughout the facility, especially north of the slag disposal area. Several vehicles are noted within the open storage area east of the discharge channel. Only revegetation activity is noted at the probable waste disposal area that was located along the south edge of the discharge channel. Several mounds of medium-toned material are evident at the north end of the discharge channel. The probable waste disposal area appears to contain several areas of light- and medium-toned material. Also visible in the probable waste disposal area are several ground scarred areas.

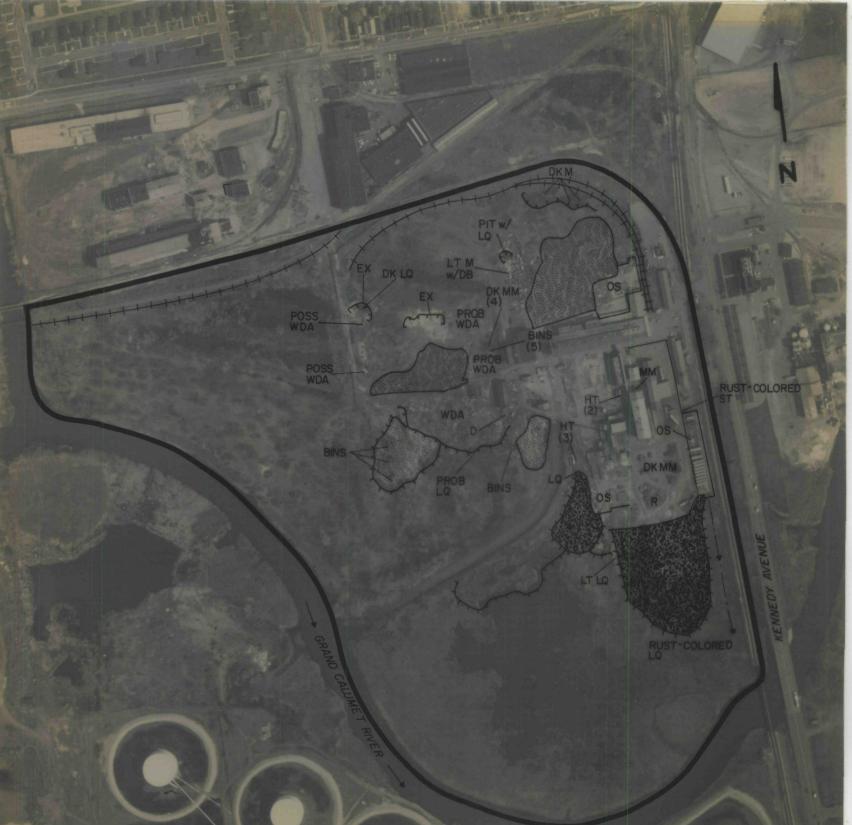
FIGURE 14 U.S. SMELTER & LEAD REFINERY

Color photography was available for this year of analysis, thus allowing for the addition of color feature descriptions to enter into the analysis. Shading patterns were used on the 1983, 1986, and 1990 prints to demonstrate the extent and locations of the dust and slag material. The fine shading pattern was used to show probable dust areas, and the coarse shading pattern was used to show the probable slag areas.

Although much of the debris and refuse noted in the previous year of analysis is no longer present, several areas are still visible. The eastern open storage area contains several crates and a few mounds of light-colored material. The possible horizontal tank noted in the north central portion of the site has been removed and is no longer present. A pit containing liquid is visible adjacent to several rust-colored probable containers and/or probable bins (not annotated). A small area of light-colored material is also noted south of the pit. Several areas of dark-colored material are discernible in the north central area where excavating was seen in 1976. Four small mounds of dark-colored material and approximately five bins are visible adjacent to the northwestern building. A small group of probable drums (D) is visible south of the westernmost building. The large excavation area along the western fenced area is still present and contains a dark-colored liquid and some probable waste material. Few mounds of material are evident throughout the facility. A rust-colored stain is seen along the eastern portion of the facility. Five dark-colored mounds of material, a pile of refuse and a few other mounds of variably tone and textured material are seen in and near the southern slag disposal area. The open storage area east of the discharge channel is empty. One large mound of medium-colored material is evident at the north end of the discharge channel. The probable waste disposal area appears to contain several areas of light- and medium-colored material, refuse, and debris. Also visible in the probable waste disposal area are several bins and an area of probable liquid.

In the area west of the facility, a large area of light-colored material containing three bins and some rust-colored material is visible.

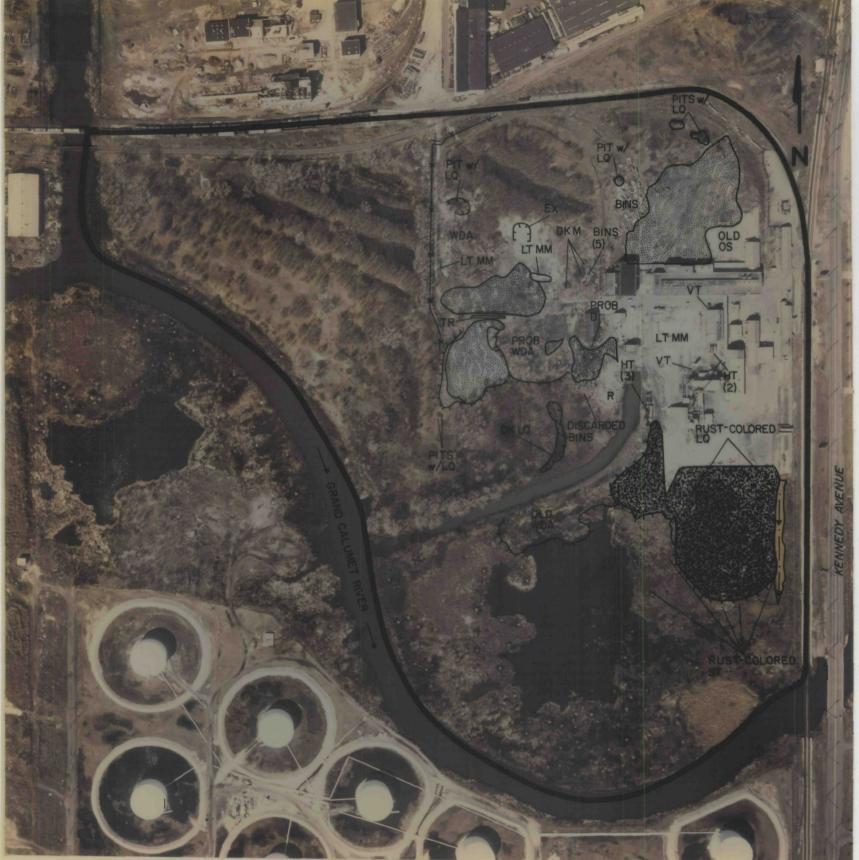
FIGURE 15 U.S. SMELTER & LEAD REFINERY

According to collateral information from EPA Region 5, the U.S. Smelter and Lead Refinery operated until December 1985. This year of photography shows the site approximately three months after its closing.

A clean-up operation has apparently been initiated. With the exception of the areas of debris and refuse, no other activity is visible at the site. Four pit areas, all containing liquid, are noted, three in the northern portion and one in the west. A multitude of discarded bins are located just north of the facility. A grey to white area of scattered material is seen north and west of the old open storage area. Three areas of dark-colored material, an area of light-colored mounded material, and a small group of discarded bins are adjacent to the most northwestern building of the facility. An area of light-colored mounded material is seen northeast of the discharge channel. This light-colored mounded material appears to be probable cover material to be used later. The slag disposal area south of the facility contains a large area of dark-colored material and several light to dark grey mounds of material. The slag disposal area is bordered by several areas of rust-colored stains and water. A large area of refuse is visible on the northwest edge of the discharge channel. Another group of discarded bins and probable equipment (not annotated) is seen adjacent to the area of refuse. The probable waste disposal area appears free from the debris and refuse seen in the previous year of analysis. An elongated area of dark-colored liquid and two more pits with liquid are discernible north of the discharge channel. A trench is evident just east of the southern part of the western fence line. The trench is empty, but two small mounds of debris are visible nearby.

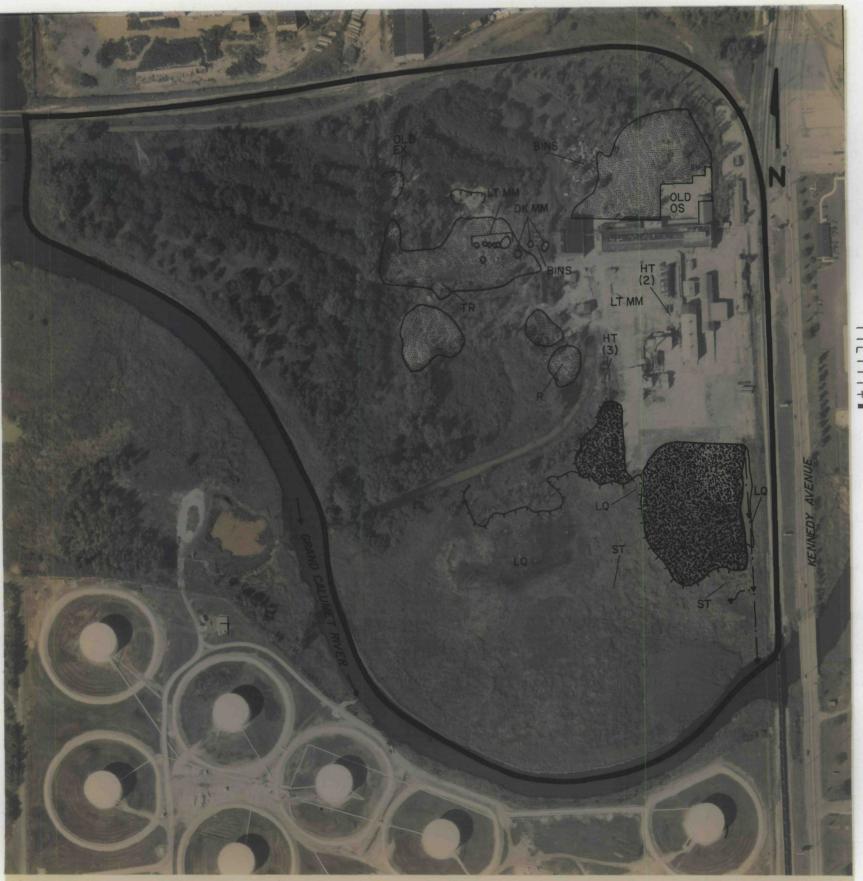
FIGURE 16
U.S. SMELTER & LEAD REFINERY

With the exception of the vegetation growth, not much change has occurred at the site.

The four pit areas which contained liquid are no longer The multitude of discarded bins that were grouped just visible. north of the facility are still present. No change is noted at the grey to white area visible north and west of the old open storage area. The three areas of dark-colored material, an area of light-colored material, and a small group of discarded bins are still visible adjacent to the most northwestern building of the facility. The area of light-colored mounded material seen northeast of the discharge channel is still present as well. The slag disposal area south of the facility contains a larger area of dark-colored material. The slaq disposal area is flanked by two areas of liquid. Two areas of rust-colored stains are seen south of the slag disposal area. The large area of refuse is still visible along the northwest edge of the discharge channel. The group of discarded bins and probable equipment (not annotated) is still adjacent to the area of refuse. The elongated area of dark-colored liquid and two pits are no longer visible north of the discharge channel. The trench is still noted just east of the southern part of the western fence line.
